Manhole Inspection Summary

Manhole # S21CC_036MH

Insp Date: **10/24/07 1:26 PM**

Location Address: **1912 RIGGS-MOSHER**

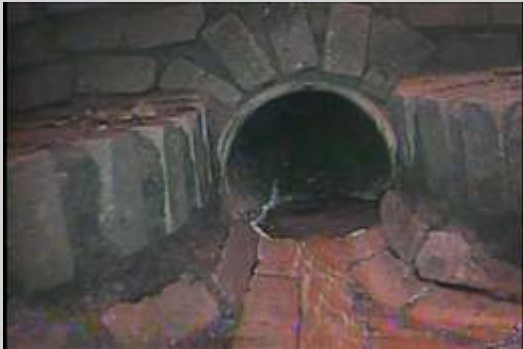
12 O'Clock Outflow

8 in. Circular Gravity Sewer
Pipe Out @ 12 O'Clock

Pipe Height: **7.2** (in.) Rod and Bar (Angled)
Pipe Material: **Clay** ☐ Pipe Lined
Invert Depth: **8.52** (ft.) Flow Characteristics: **Slow**
Deposits: ☒ None ☐ Mud ☐ Sludge ☐ Debris ☐ Grease
Silt Depth: (in.) Deposits Extent:
Infiltration: **None** Pipe Seal Cond: **Sound**

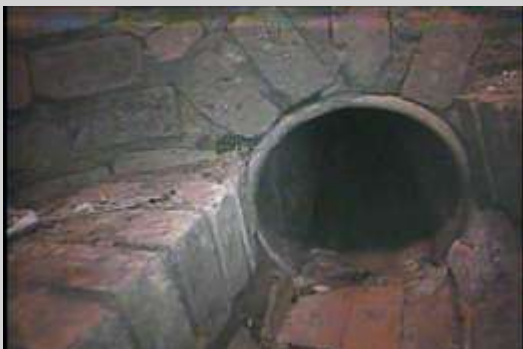
3 O'Clock Inflow

8 in. Circular Gravity Sewer
Pipe In @ 3 O'Clock

Pipe Height: **8.4** (in.) Rod and Bar (Angled)
Pipe Material: **Clay** ☐ Pipe Lined
Invert Depth: **8.20** (ft.) Flow Characteristics: **Slow**
Deposits: ☒ None ☐ Mud ☐ Sludge ☐ Debris ☐ Grease
Silt Depth: (in.) Deposits Extent:
Infiltration: **None** Pipe Seal Cond: **Sound**

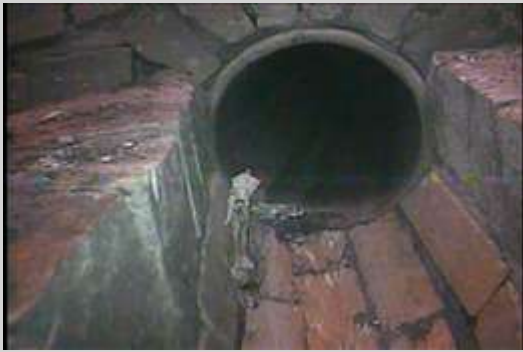
6 O'Clock Inflow

8 in. Circular Gravity Sewer

Pipe In @ 6 O'Clock

Pipe Height: **8.4** (in.) Rod and Bar (Angled)

Invert Depth: **7.93** (ft.) Flow Characteristics: **Slow**

Infiltration: **None** Pipe Seal Cond: **Sound**

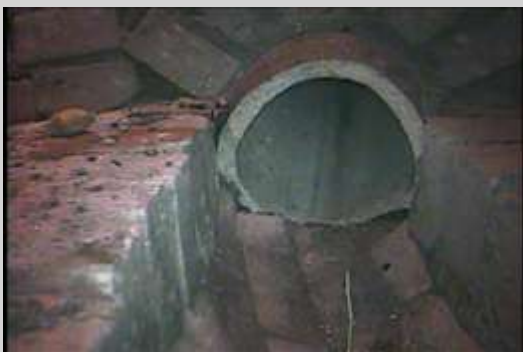
9 O'Clock Inflow

6 in. Circular Gravity Sewer

Pipe In @ 9 O'Clock

Pipe Height: **6** (in.) Rod and Bar (Angled)

Infiltration: **None** Pipe Seal Cond: **Sound**
